Intel[®] Pentium[®] II Xeon[™] Processor Specification Update

Release Date: November 2000

Order Number: 243776-026

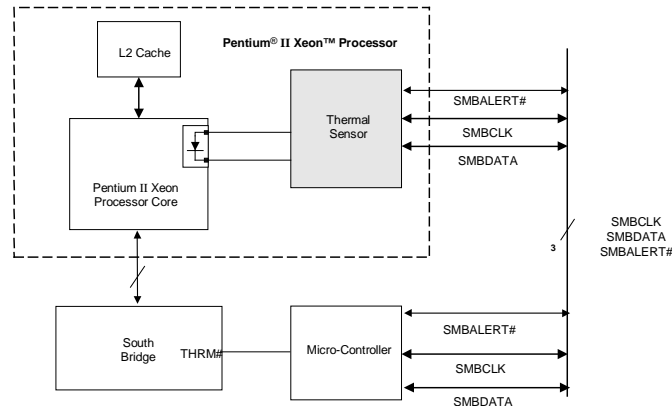
Figure 1. An Example of Microcontroller Driven Thermal Management

D30. Thermal Sensor May Assert SMBALERT# Incorrectly

Problem: The Pentium II Xeon processor has a thermal sensor that monitors the processor core's temperature. The thermal sensor asserts SMBALERT# if the processor temperature exceeds the temperature limits set in the Alarm Threshold Registers (T_{HIGH} , T_{LOW}). It also sets the corresponding Status Register bits to identify the cause of the interrupt. Figure 1 gives one example of how the SMBALERT# signal could be used in a system.

Under the conditions described below, the thermal sensor incorrectly generates the SMBALERT# interrupt. All of the following conditions must be met to trigger a false interrupt:
